# Manhole Inspection Summary

Manhole # S51C\_\_027MH

**Inspection** ☐ Is Incomplete Rating: **3) Fair**

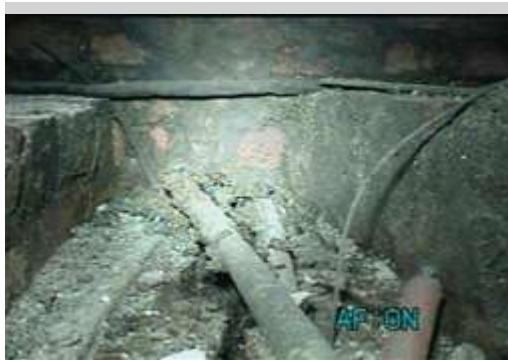
Defect 3

Condition: ☐ Sound ☐ Cracked ☐ Root Intrusion ☐ Deteriorated ☐ Leaks ☒ **Debris**

channel debris

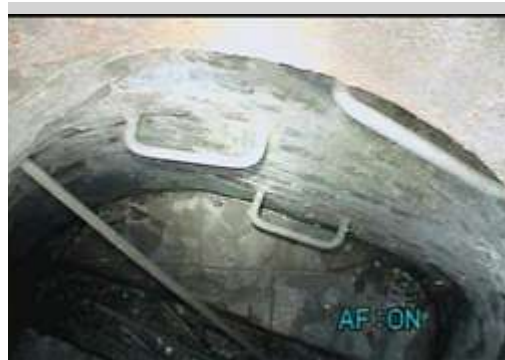
Defect 2

**Steps** Count: **3** Missing: **0** ☒ **Corroded**

steps

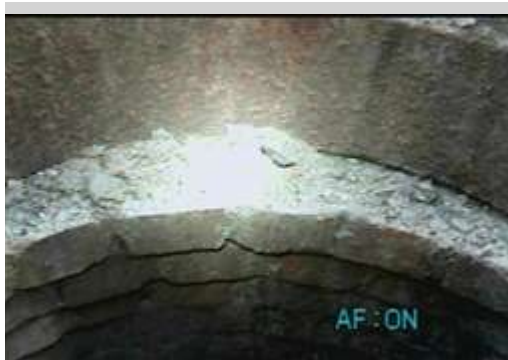
Defect 1

**Frame** Offset: **4** (in.) Condition: ☒ Sound ☐ Cracked ☐ Leaks

offset

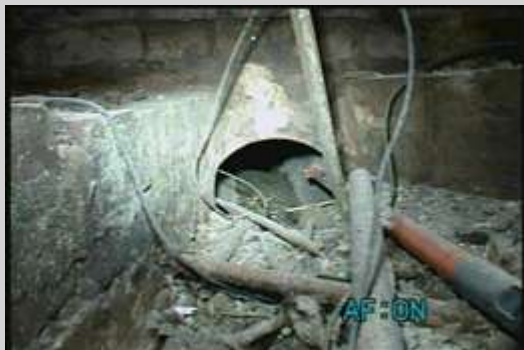
12 O'Clock Outflow

8 in. Circular Gravity Sewer  
Pipe Out @ 12 O'Clock

Pipe Material: **Clay** ☐ Pipe Lined

Invert Depth: **6.31** (ft.) Flow Characteristics: **None**

Deposits: ☒ None ☐ Mud ☐ Sludge ☐ Debris ☐ Grease

Infiltration: **None** Pipe Seal Cond: **Unknown**
